# The Backbone Campaign

**T E C H N I C A L   M E M O R A N D U M**

**RE: ENVIRONMENTAL EVALUATION  
K2 CORPORATION FACILITY  
VASHON ISLAND, WASHINGTON  
FARALLON PN: 1271-001**

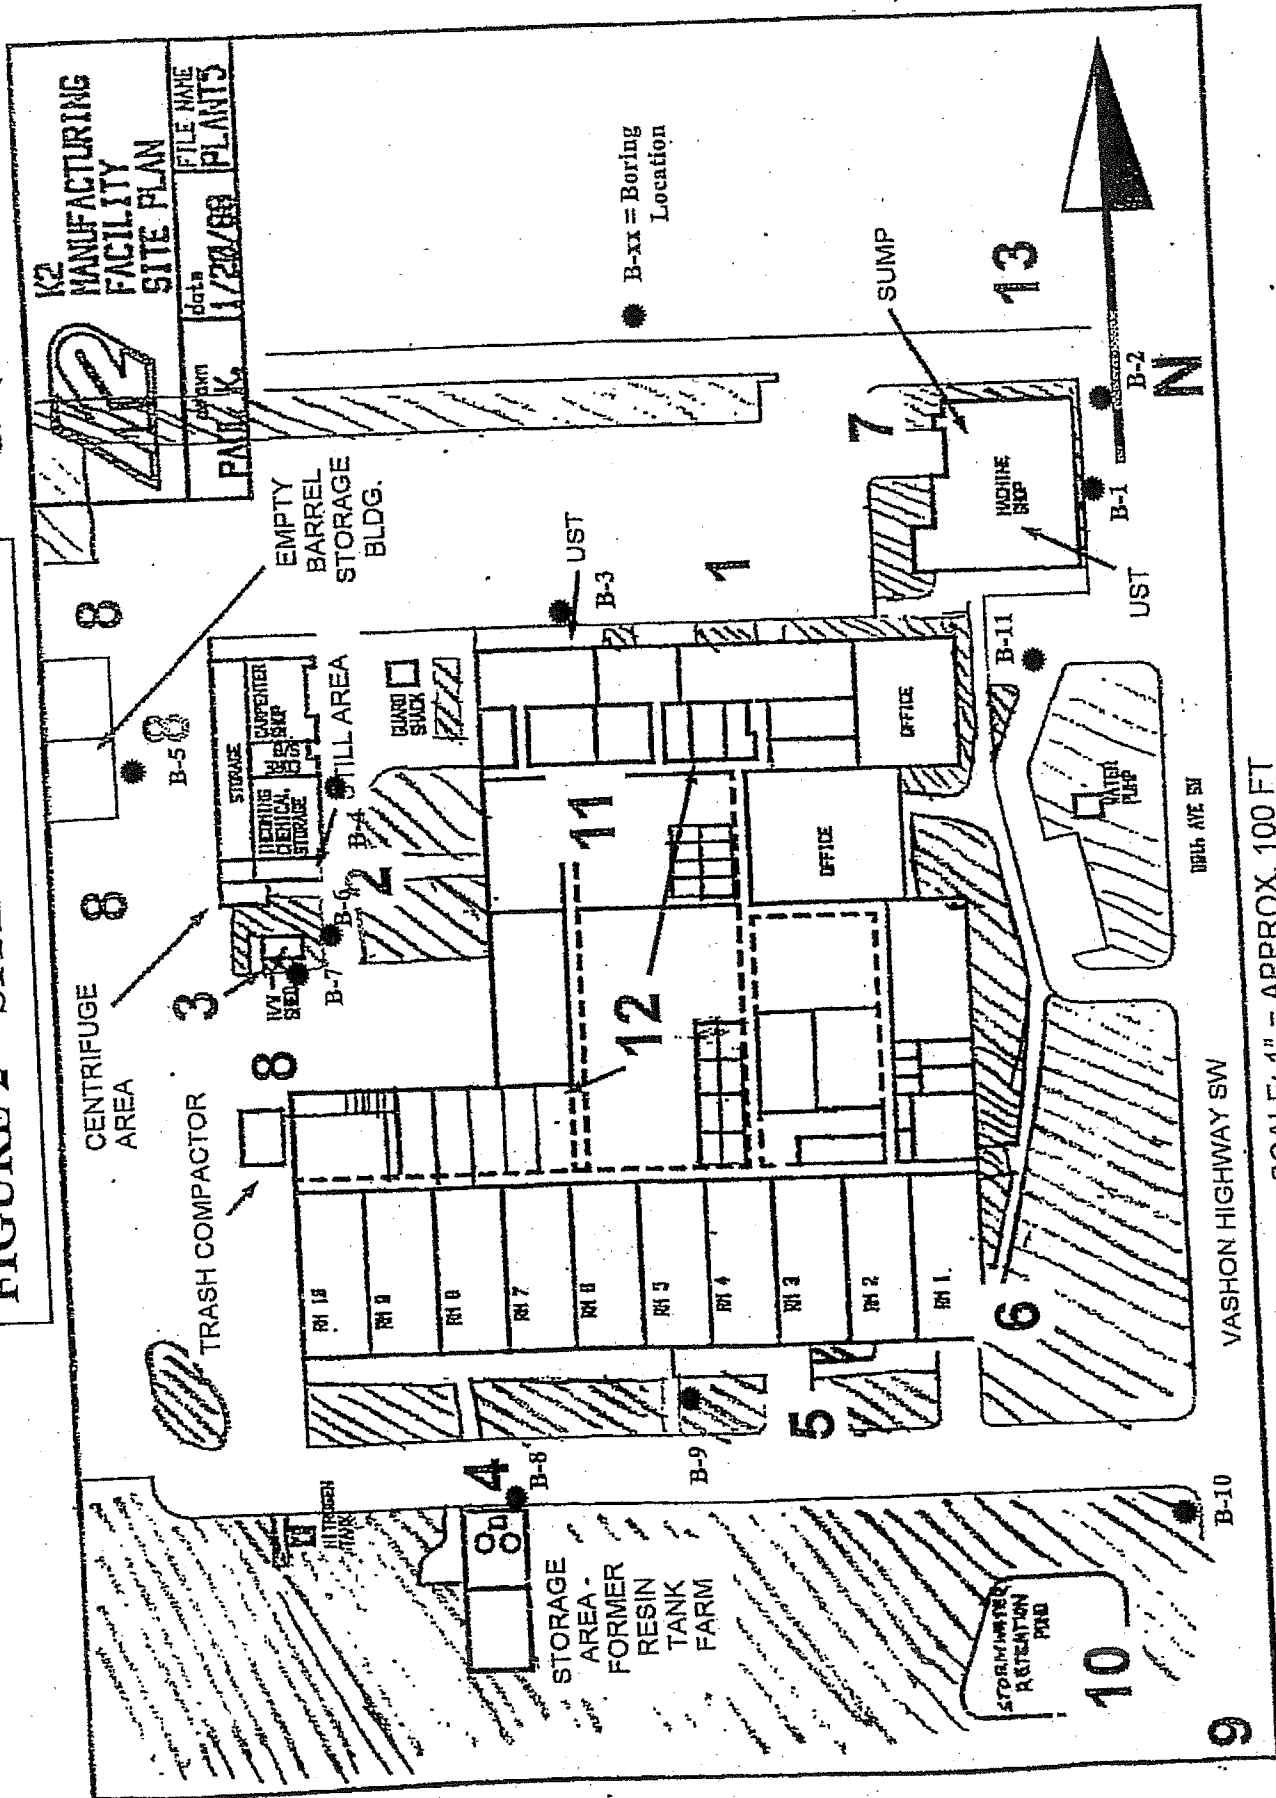
FIGURE 2 - SITE MAP

Recognized environmental conditions were identified in Section 8 of the Phase I ESA report and on pages 1 through 3 of the Phase II ESA report. The locations of the recognized environmental conditions are shown on Figure 2 of the Phase II ESA report, and Table 1 describes the purpose of each boring drilled for the Phase II ESA. Below are preliminary comments regarding the work performed by White Shield, Inc. to address the recognized environmental conditions and to characterize "existing conditions" and areas where Farallon expects Ecology would require collection of additional data sufficient to provide an Opinion Letter for the K2 facility:

- Install 11 "Geoprobe" borings at selected locations around the facility to investigate the potential for soil and/or groundwater contamination. The locations of the borings are shown on Figure 2. Table 1 identifies the borings, the purpose of each boring, the media of concern, and the potential contaminants of concern.
- Sample soil and/or groundwater for location-specific contaminants of concern.
- Prepare a summary report documenting the analytical results and findings. The report would also contain recommendations for further work if needed.
